**OAKWOOD CEMETERY CHAPEL**  
**Austin, Texas**  
**FEASIBILITY REPORT**

**HEIMSATH ARCHITECTS**

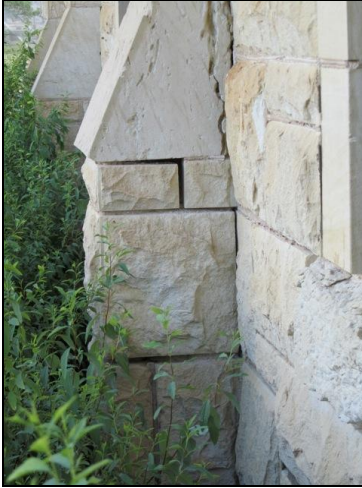
*Open joints & displaced stones*

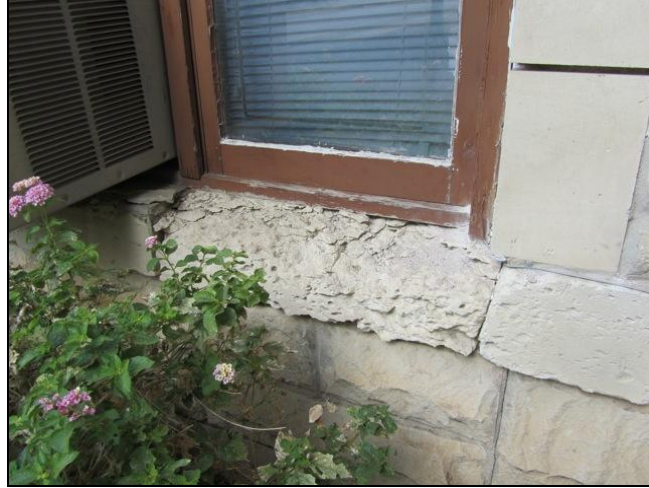
*Open joints and badly deteriorated stone sill*

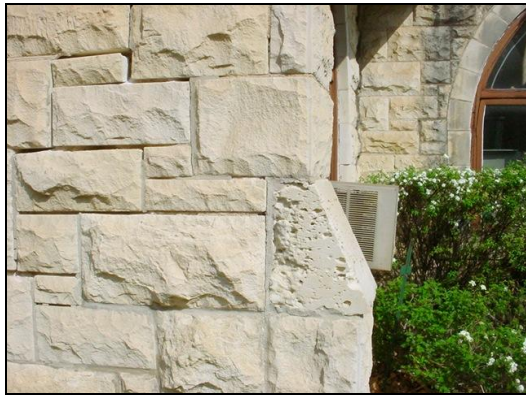
*Open mortar joints, cracks and deteriorated stone*

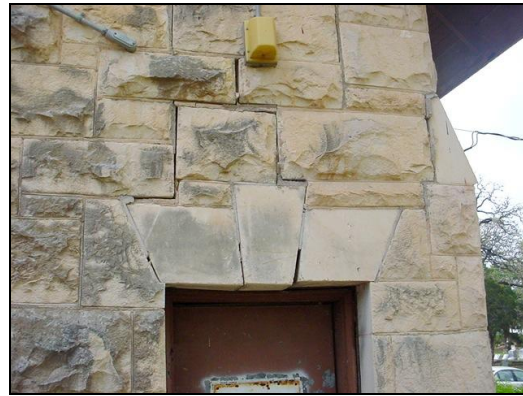
*Cracking above north door*

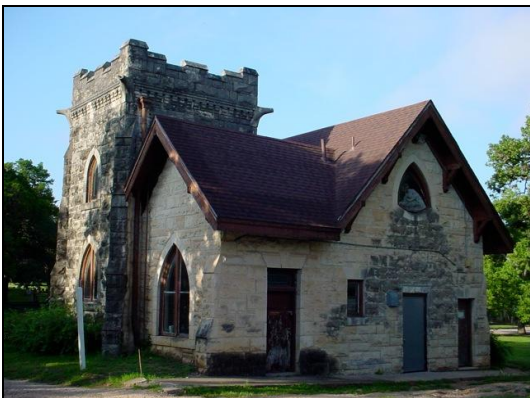
*Mildew stains on tower and north wall of chapel*

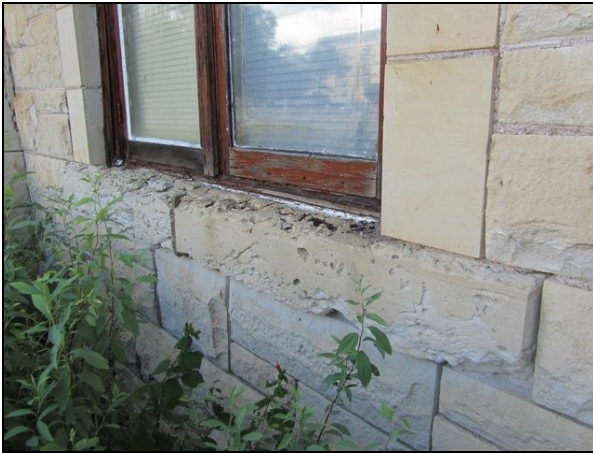
*Rotted windowsill on west facade*

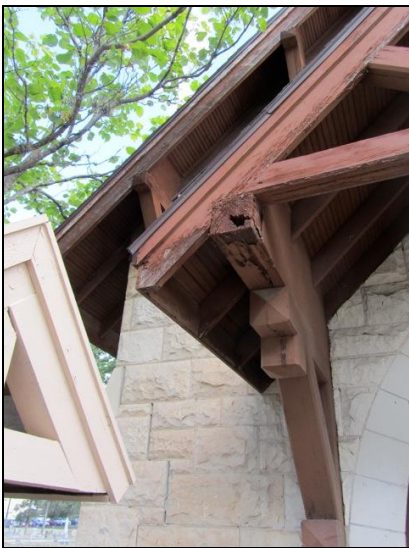
*Rotted wood bracket*

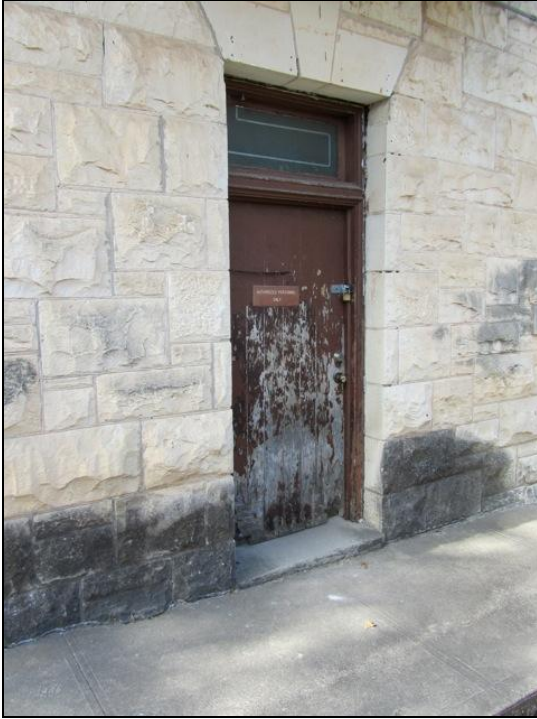
*Rotted wood door on north façade*

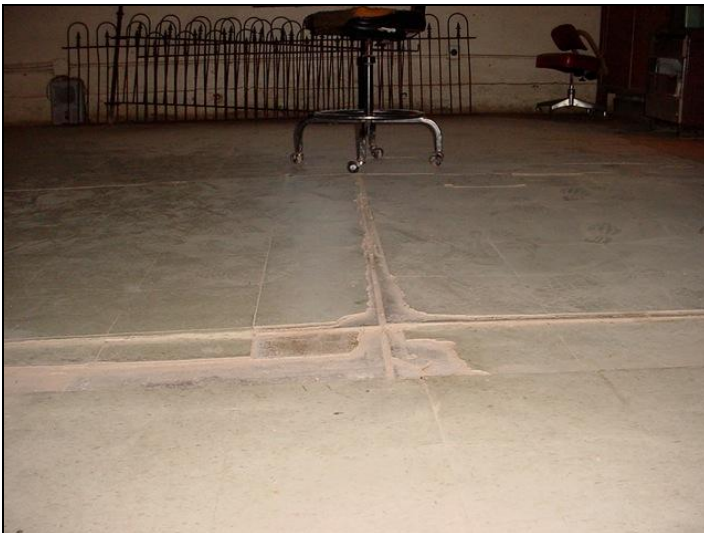
*Uneven floor surface with asbestos tile (SAC Photo)*

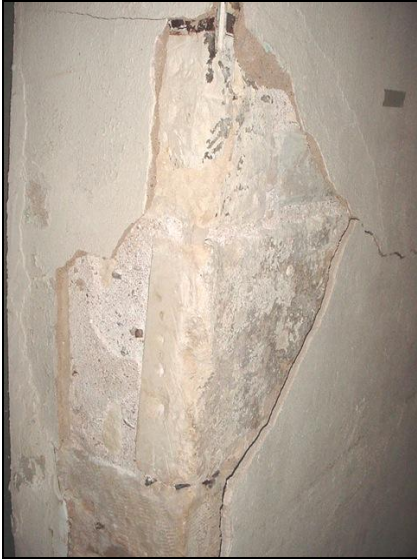
*Plaster delamination*

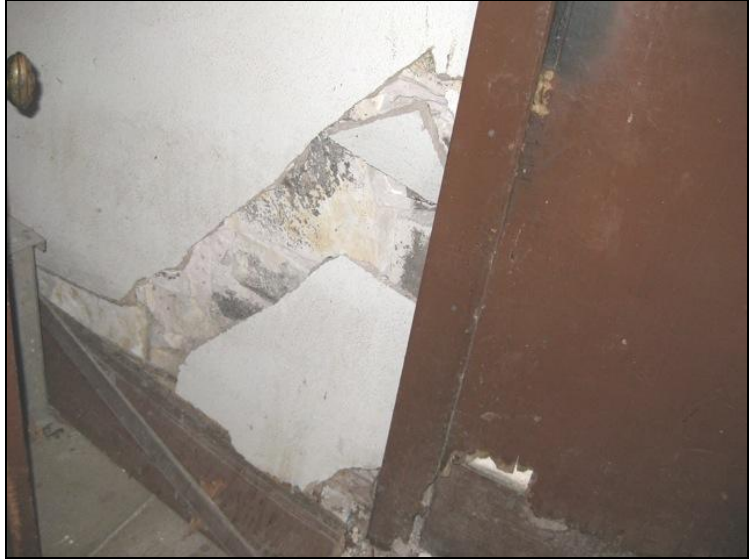
*More plaster damage*

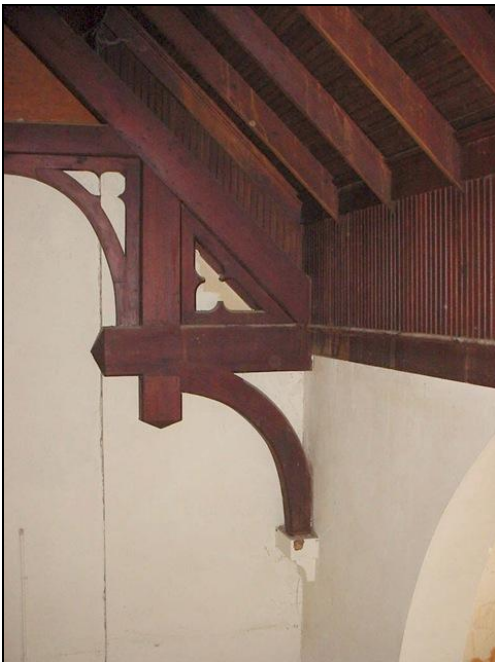
*Water stains on interior wood*

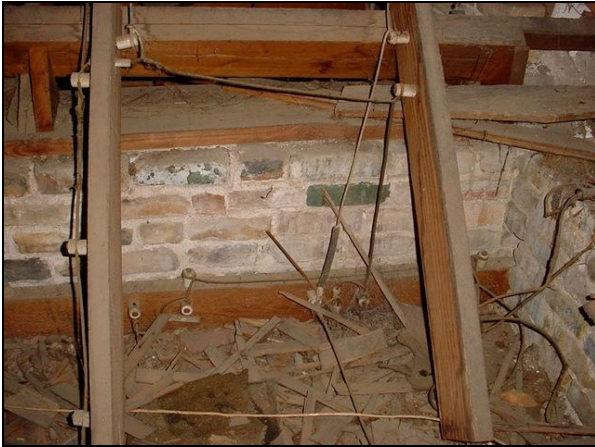
*Old knob and tube wiring*

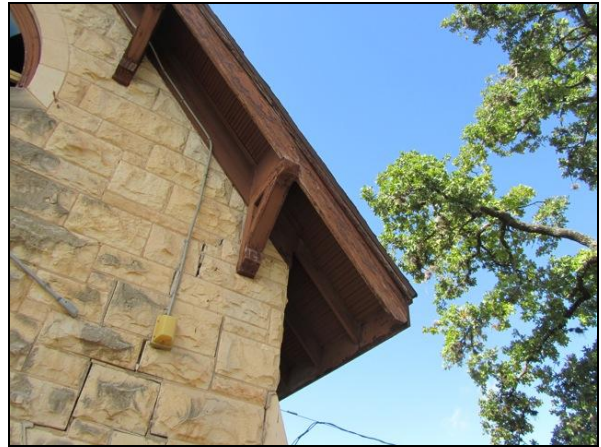
*Surface mounted electrical*
