Oakwood Cemetery

The photos that follow document 5 hrs of site work where by the grass and ½ inch of soil was removed from the surface using small trowels and brushes. This site is a slight hump in the lawn in an open area that is in a lower area of the cemetery. Damage has been noted in the past by lawn equipment. In an effort to protect the site, I chose to do a surface removal of the grass that has over grown the site and document the site.

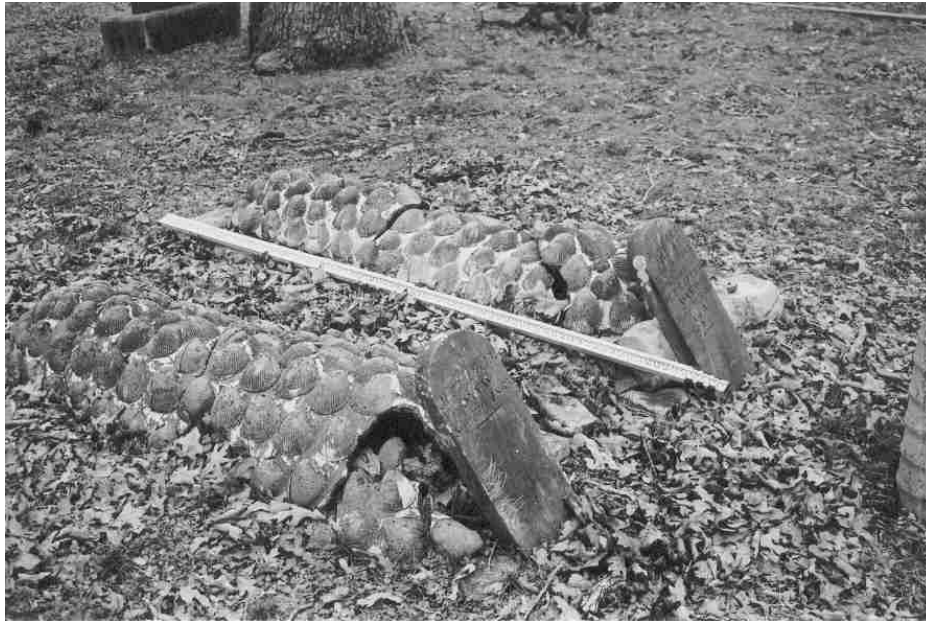
Photo 1
Feb 2001

Mounded gravesite's in section 1 old grounds. Sea shells embedded in concrete. Dirt mound has settled, leaving the arch unsupported. The concrete form is breaking. These are 2 of 3 surviving examples of sea shell used at Oakwood Cemetery found to date. These two sites are marked with headstones and have changed little in the past five years. These are not the site in question.

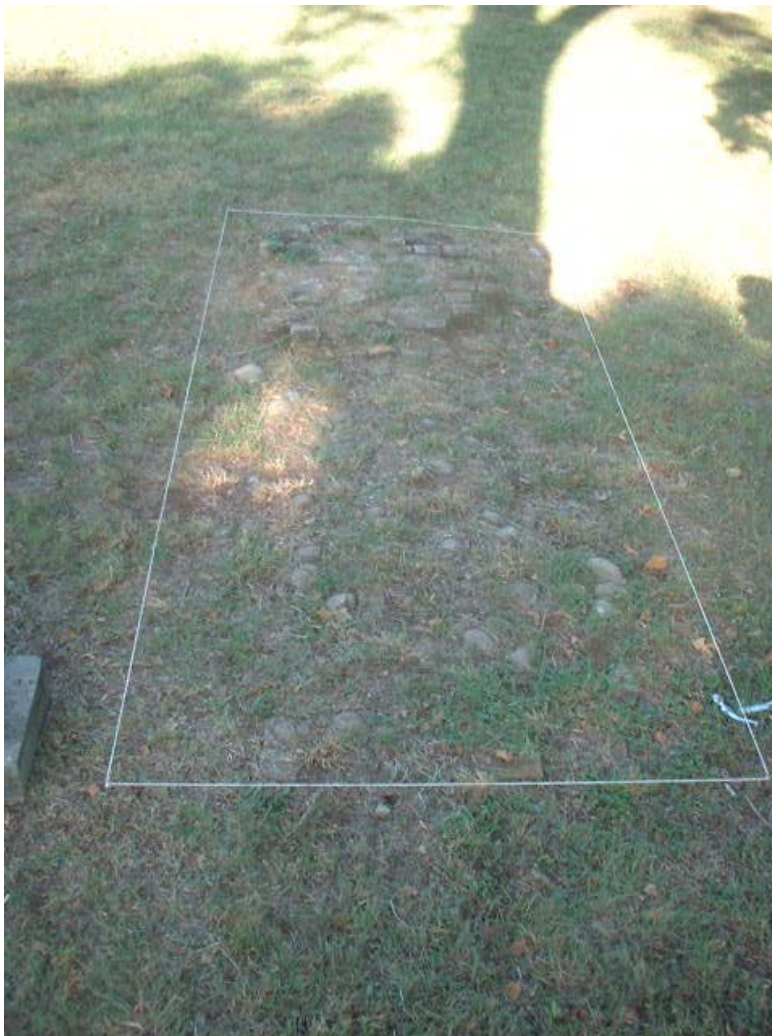
Photo 2
Aug 2005

View looking westward. Site is approximately 4.5 feet wide by 7 feet long.
Embedded brick and shells marking a suspected gravesite

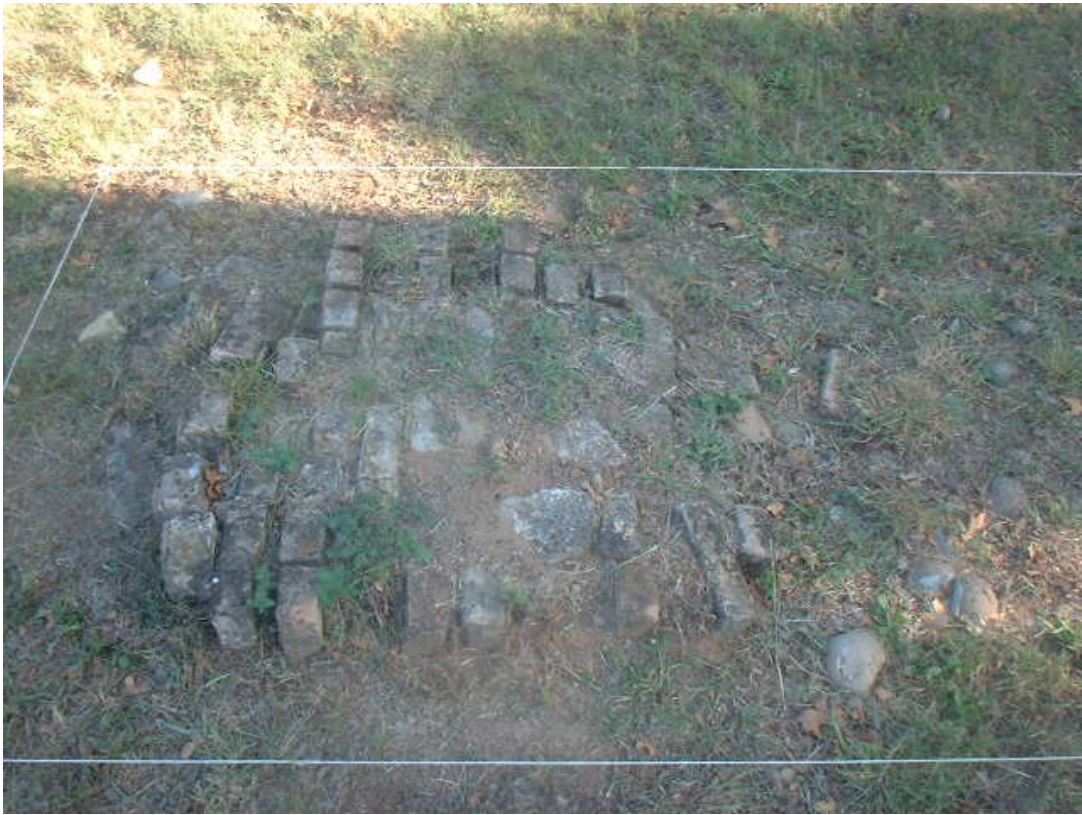
Photo 3
Aug 2005

West end of gravesite view looking north, brick and shells seen in the grass.
Signs of current damage, from mower / string trimmer noted on brickwork. Site has been covered by years of sediment and leaf litter

Note height of brick above the grade

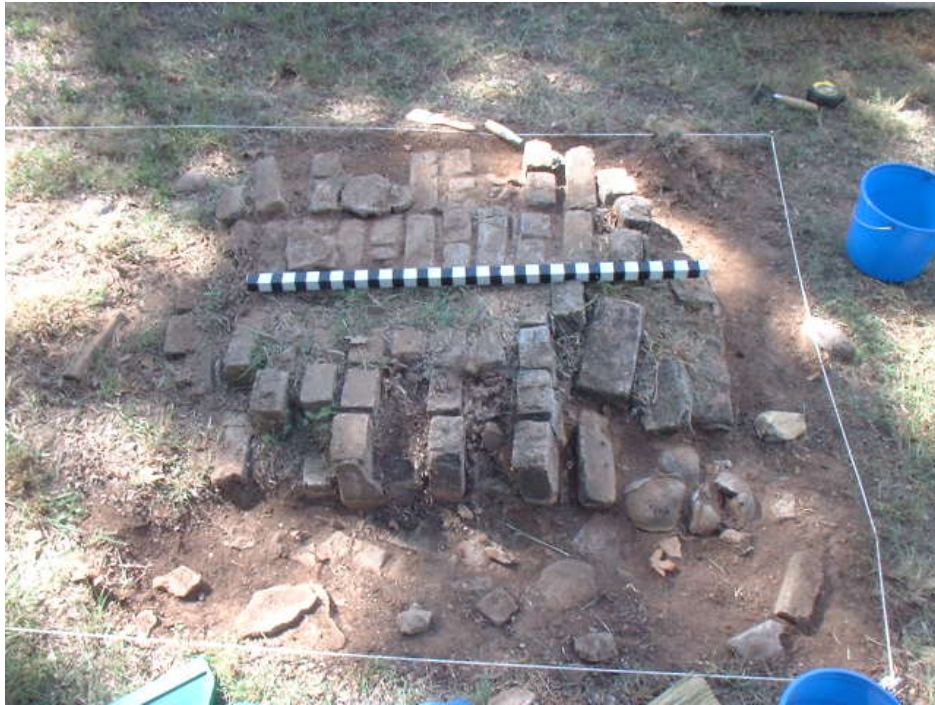
Photo 4

West end of mound, view looking south ward, scale on bar is 1 sq inch
Grass and ½ inch of soil has been removed

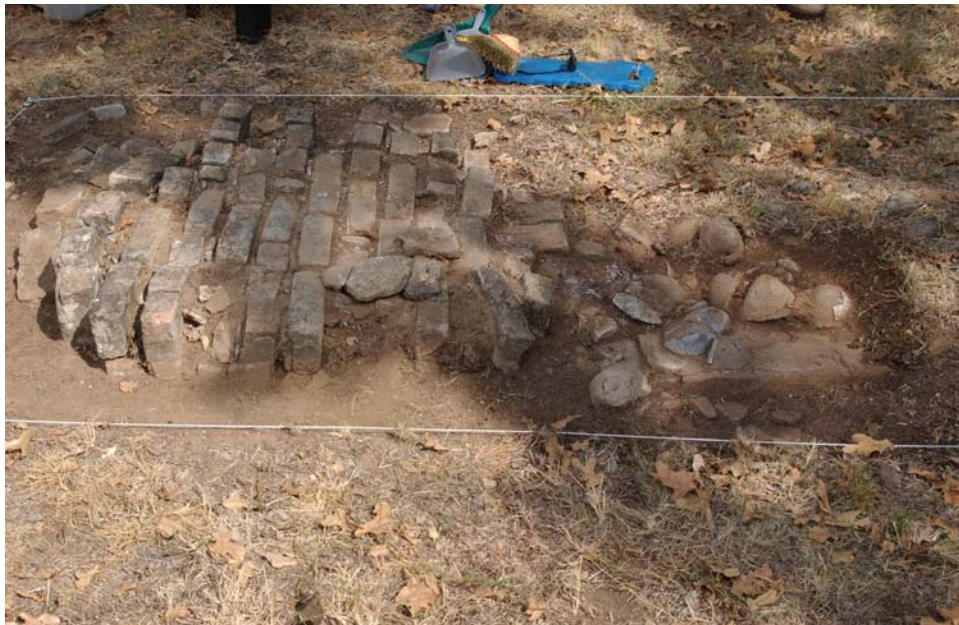
Photo 5

Note photo 3, same view. Grass and ½ inch of soil removed.
Note what appears to be a concrete slab, east of the brick

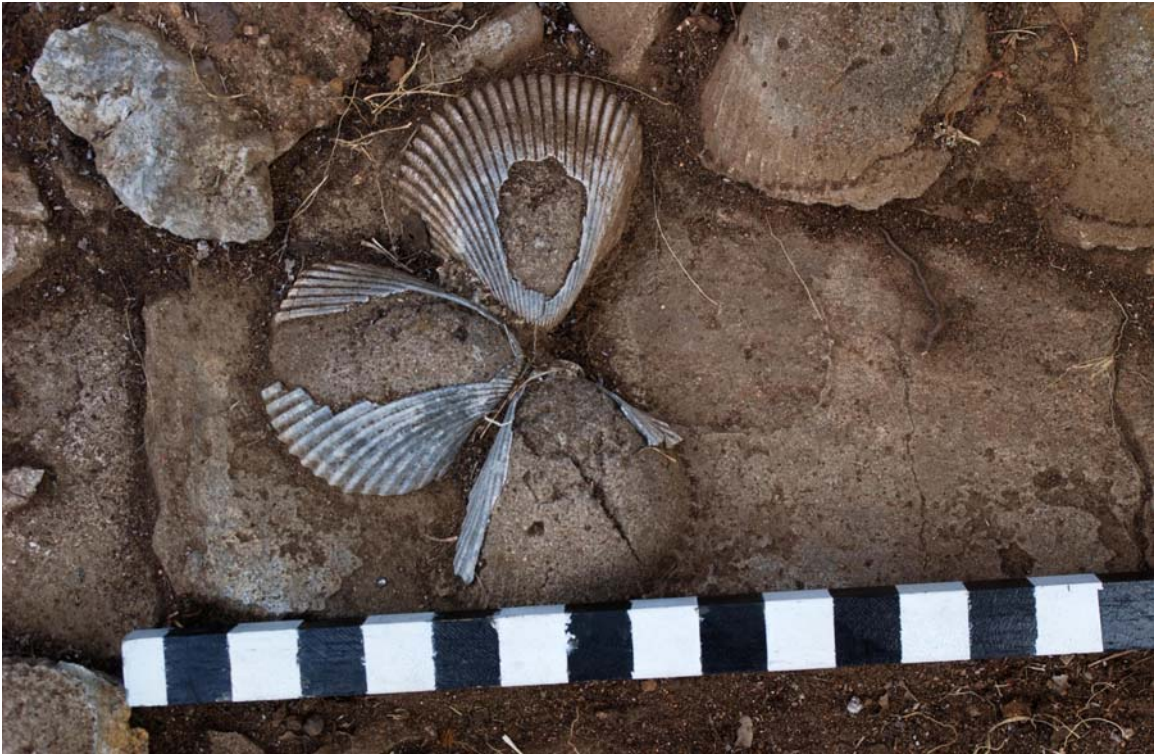
Photo 6

Close up of SW corner of what appears to be a concrete base.
Note the imprint of the missing shell on the concrete
